TODAY'S RAILWAY SAFETY

PROGRESS SINCE 1940

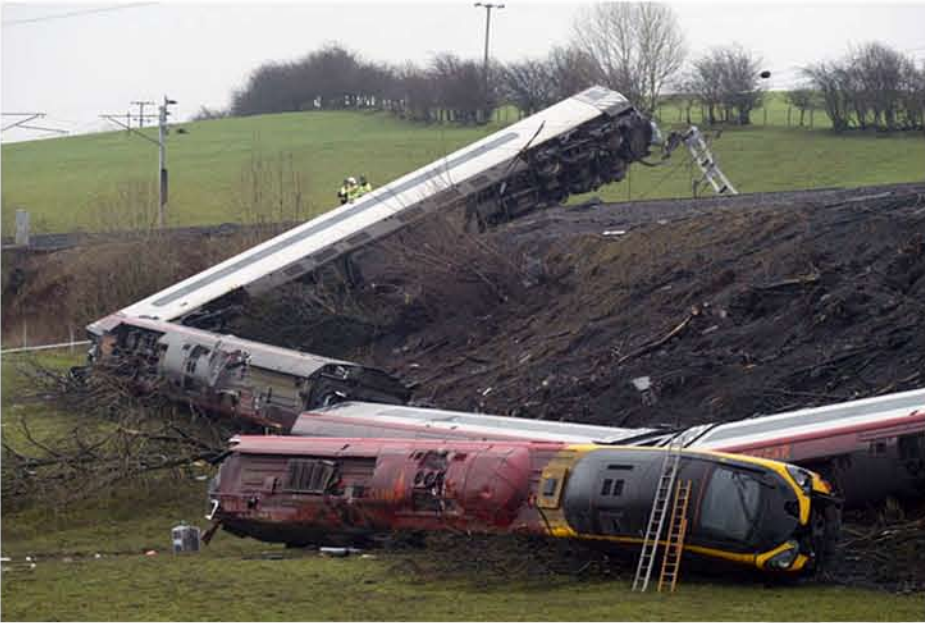
The concept of rail vehicle structural crashworthiness has developed significantly since the two accidents at Norton Fitzwarren. Wooden-bodied coaches have been replaced by welded steel or aluminium bodies which provide a strong 'survival cell' if there is a serious crash. 'Telescoping' of coaches is further prevented by having strong pillars at the end of vehicles and devices that prevent carriages from 'climbing' over each other. Inside the carriages, the likelihood of secondary injuries is reduced by improved furnishings at fittings (that do not become detached when there is a crash) and by using fire-resistant materials.

The crashworthiness of modern rolling stock was shown in an accident very similar to the 1940 Norton Fitzwarren accident - at Grayrigg in 2007. Here, a train derailed at a set of defective points. The train was travelling at 95 mph, and eight of the nine vehicles fell down an embankment. One passenger was fatally injured and the train was seriously damaged. However, there was no significant loss of passenger or crew survival space.

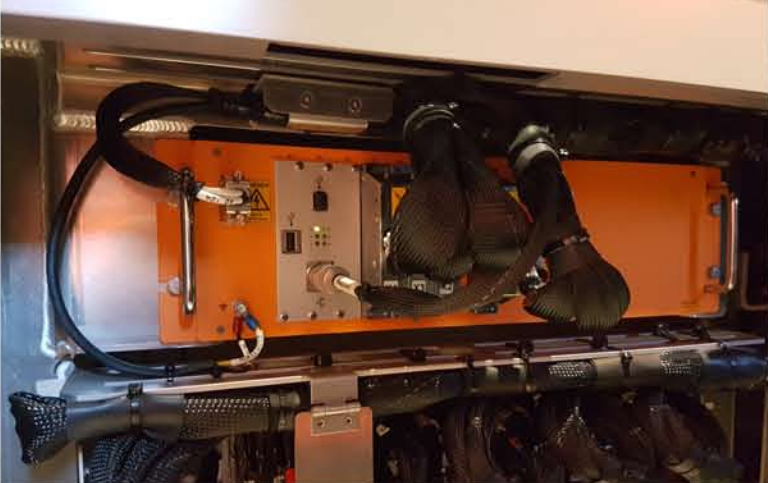
Modern railway vehicles, like aircraft, have 'black boxes' (actually they're orange) fitted that record the driver's actions and data about the train (speed, location, distance travelled). This data is held in a crash-proof device that can be downloaded after an accident. Signalling centres have similar equipment and voice communications are all recorded. This all adds to the evidence available to investigators to work out what happened.
